# Hilton Hotel, Sydney

## Case Study

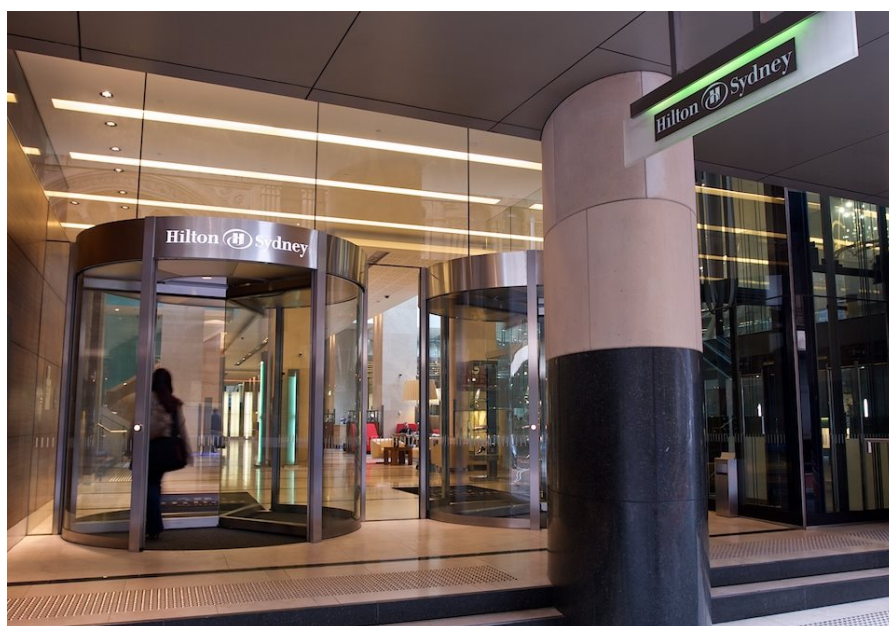
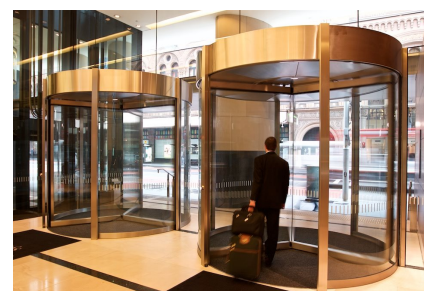
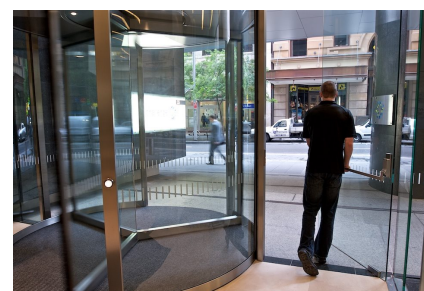
With the existing main entry sliding doors on George Street, as well as the rear entry off Pitt Street, causing persistent wind problems for hotel staff and guests, the decision was made to replace these sliding doors with revolving doors to achieve airlocked entries to the hotel.

In an extensive site operation, the existing sliding doors were removed, along with the highlight glazing which was being supported off the steel transom.

Two Fullview revolving doors were then installed to the George Street entry, along with one Fullview door and motorised swing door to the Pitt Street entry. All doors were clad in lined stainless steel with custom illuminated canopy signage.

To maintain the existing requirement for smoke ventilation in an emergency, each revolving door was fitted with an automatic windback door wing to open on a fire trip signal.

For greater security after hours, the doors were fitted with motorised 'clamshell' night doors, which are in fact the sidewalls of the doors themselves automatically closing and electrically locking once the door, and associated lighting is turned off.
