100 Market Street, Sydney

Case Study

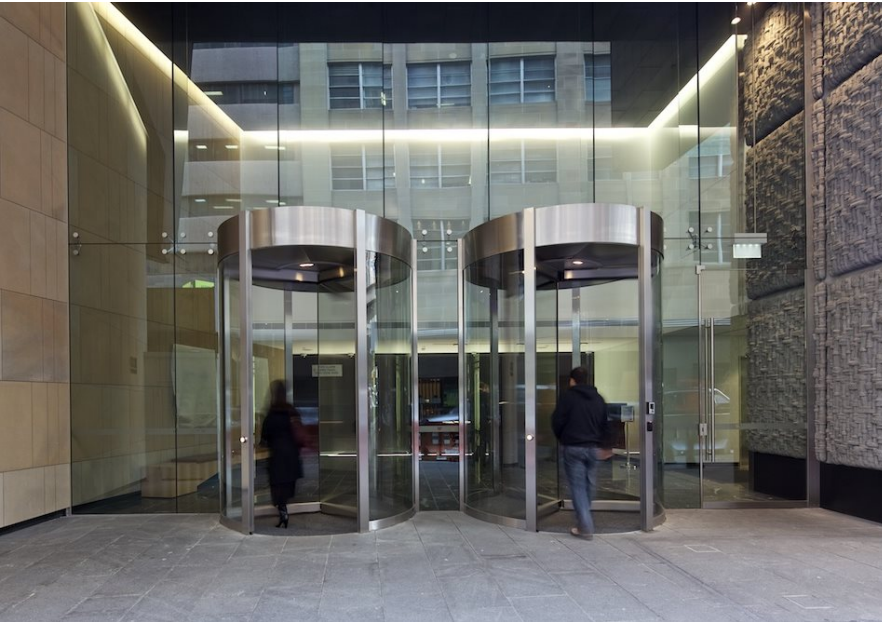
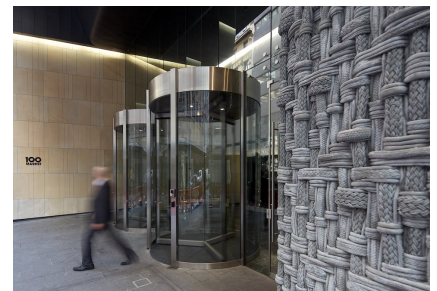
At 2400mm diameter and 3420mm high these finished stainless steel clad revolving doors provide a striking and tall entrance feature to complement the frameless glazing and feature wall claddings on either side.

Completed in 2010, this refurbishment entailed the pre-cast concrete facade being removed and replaced with a new high performance glass facade, new interior fit out to all floors, which included modified floor plates with new light wells to increase natural light and a new frameless glass assembly to the main entry with two Fullview Series revolving doors.
